DOT/FAA/AR-99/20, P1

Development of a Supplemental Inspection Document for the Fairchild SA226 and SA227 Aircraft, Part 1

Technical Report

REPORT NO. R1517

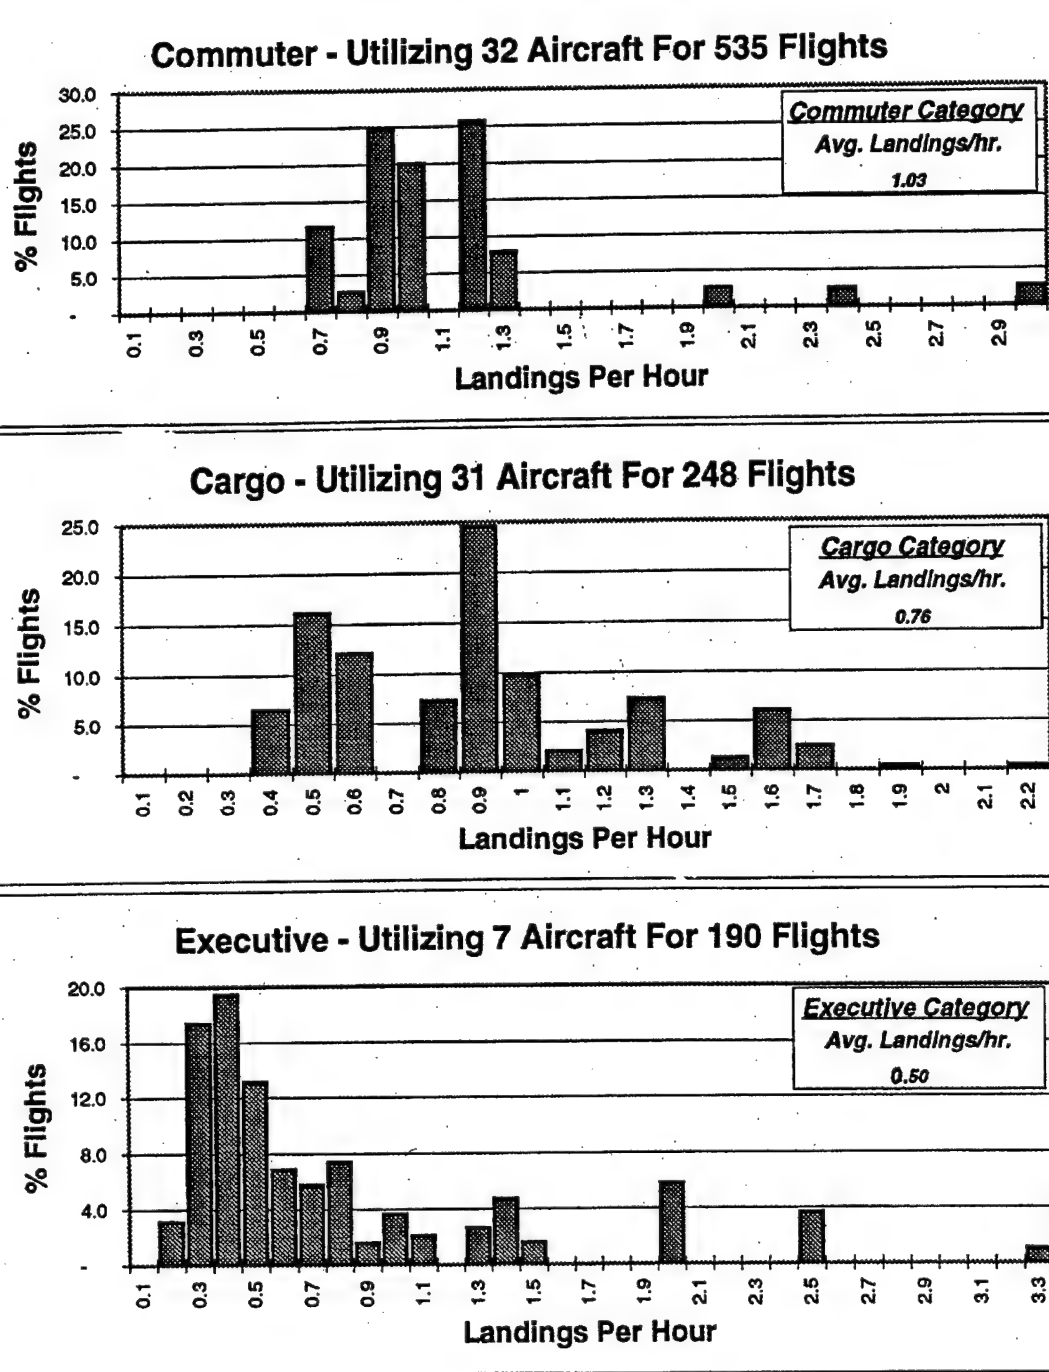
FIGURE 2-1 LANDING FREQUENCY COMPARISON

Figure 2-1 shows histograms of the three operation categories illustrating the number of flights vs. landings per hour.

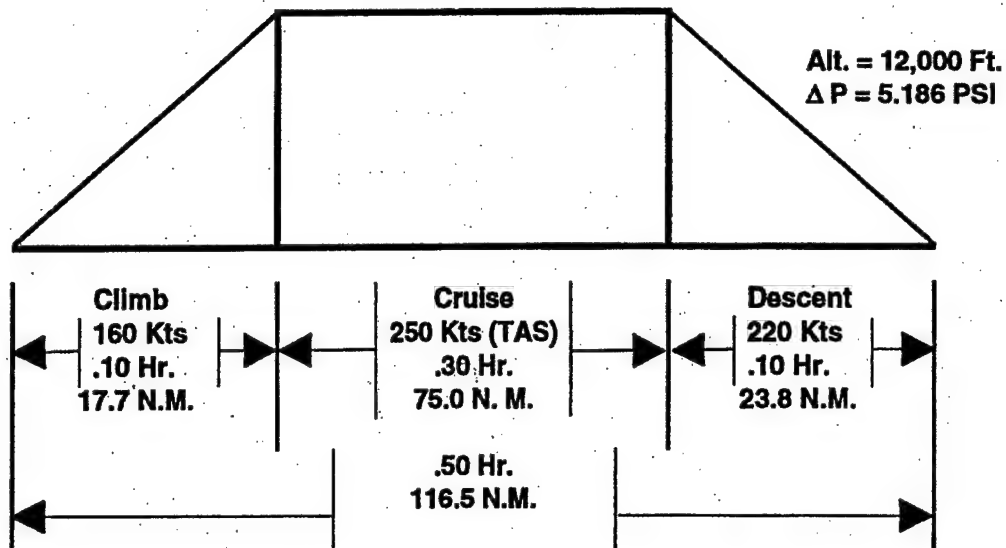
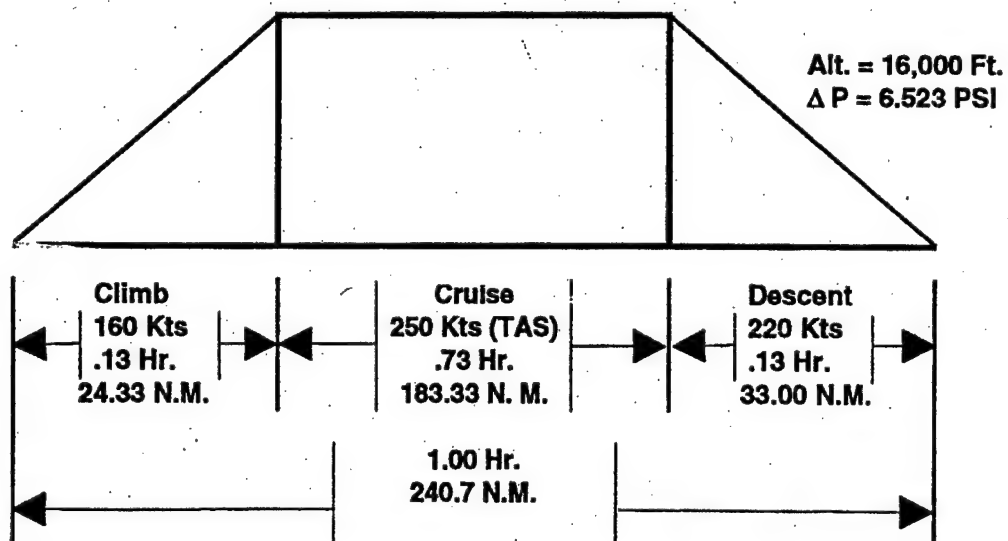
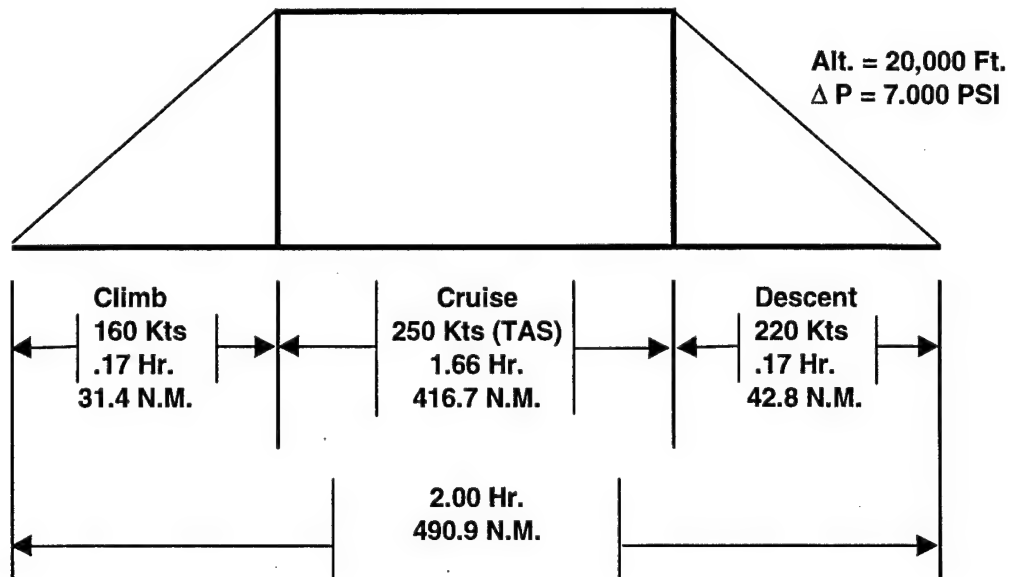
FLIGHT PROFILE - GROUP 1

FLIGHT PROFILE - GROUP 2

FIGURE 3-1 FLIGHT PROFILE ILLUSTRATION

FLIGHT PROFILE - GROUP 3

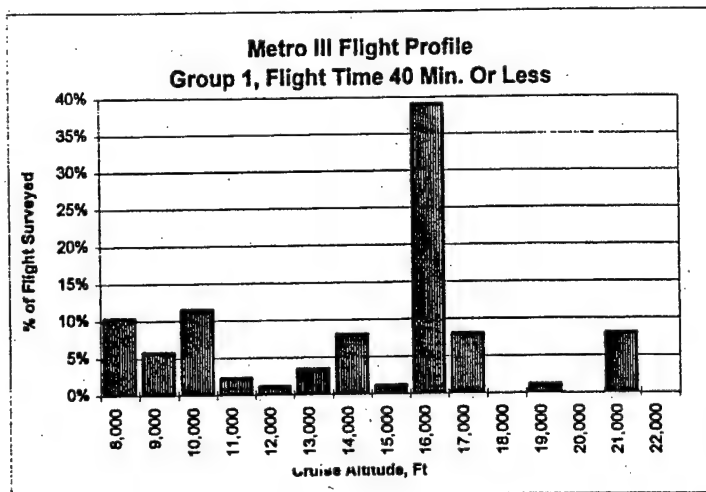
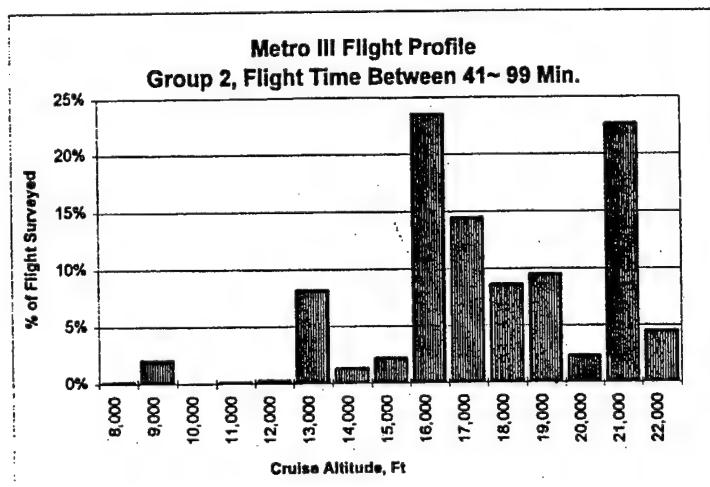
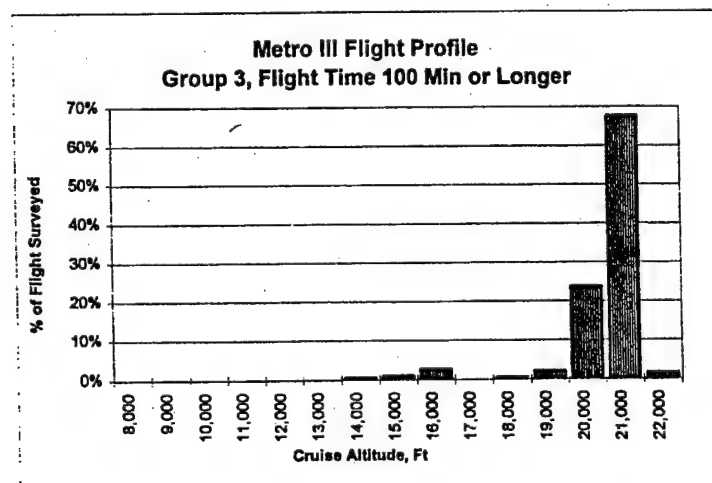
FIGURE 3-3 FLIGHT PROFILE - CRUISE ALTITUDE

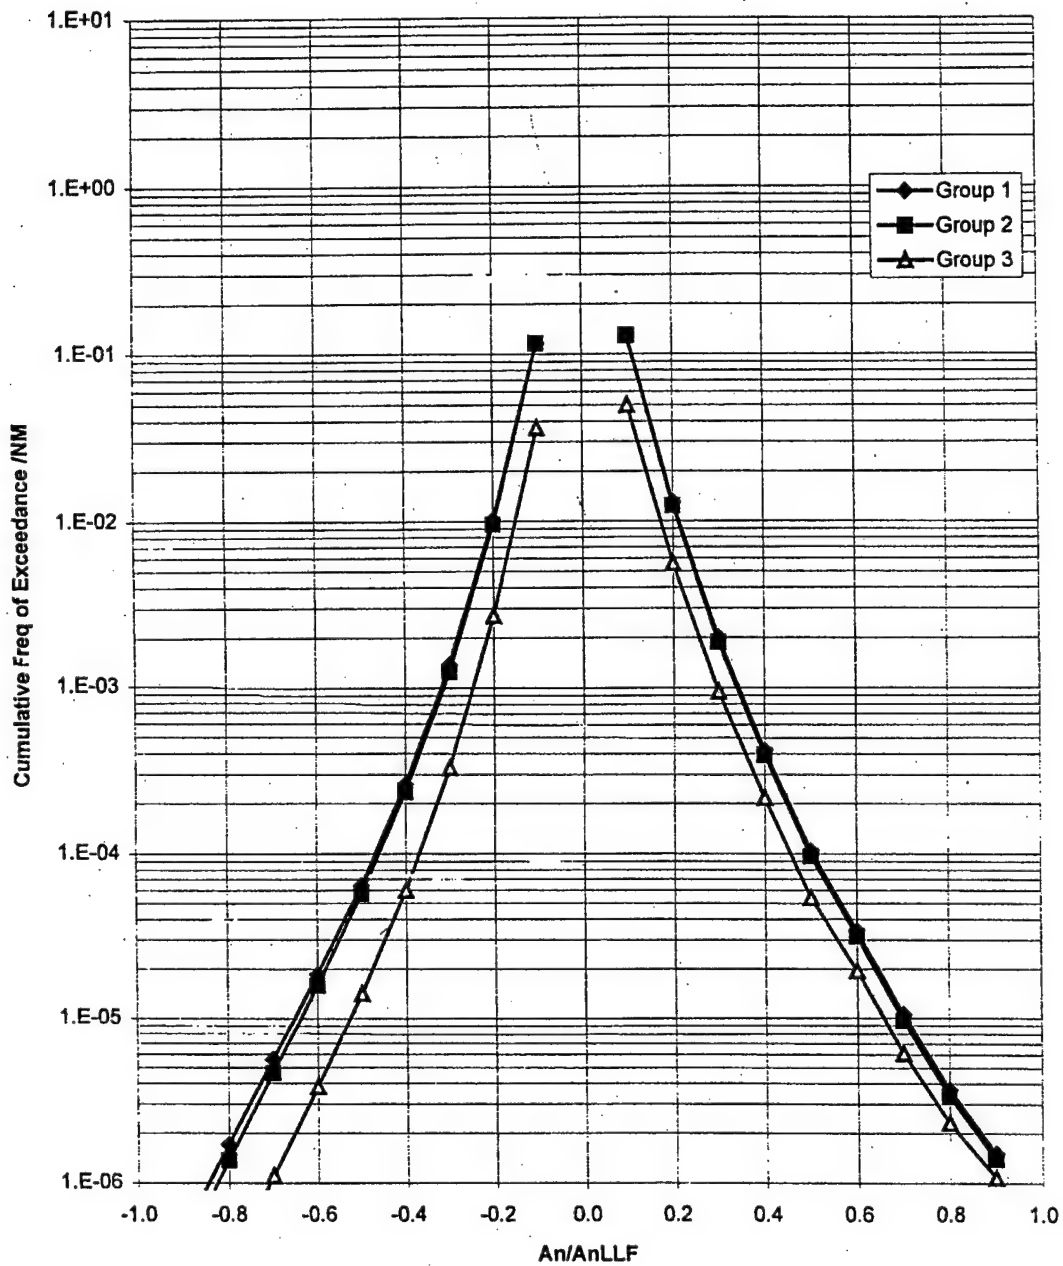
Gust and Maneuver Load Spectra for Metro III

FIGURE 4-1 SA227 MANEUVER AND GUST SPECTRUM

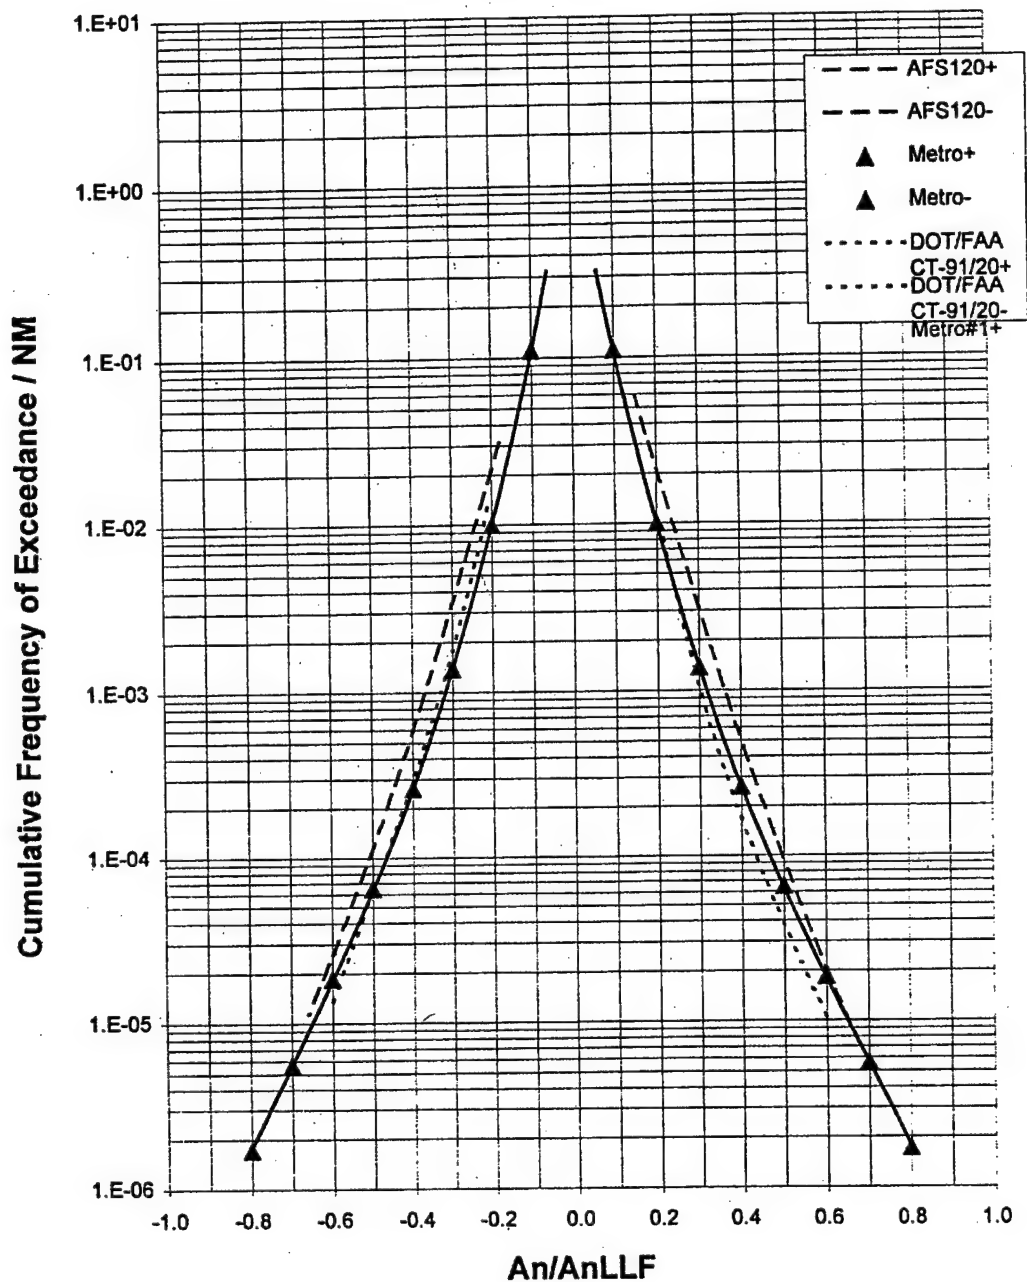
Load Spectra Comparison Metro III
Gust, Group 1, 30 Min, 12,000 FT, 12,800 LB TO Wt.

FIGURE 4-2 GROUP 1 FLIGHT PROFILE
VERTICAL GUST LOADS EXCEEDANCE COMPARISON

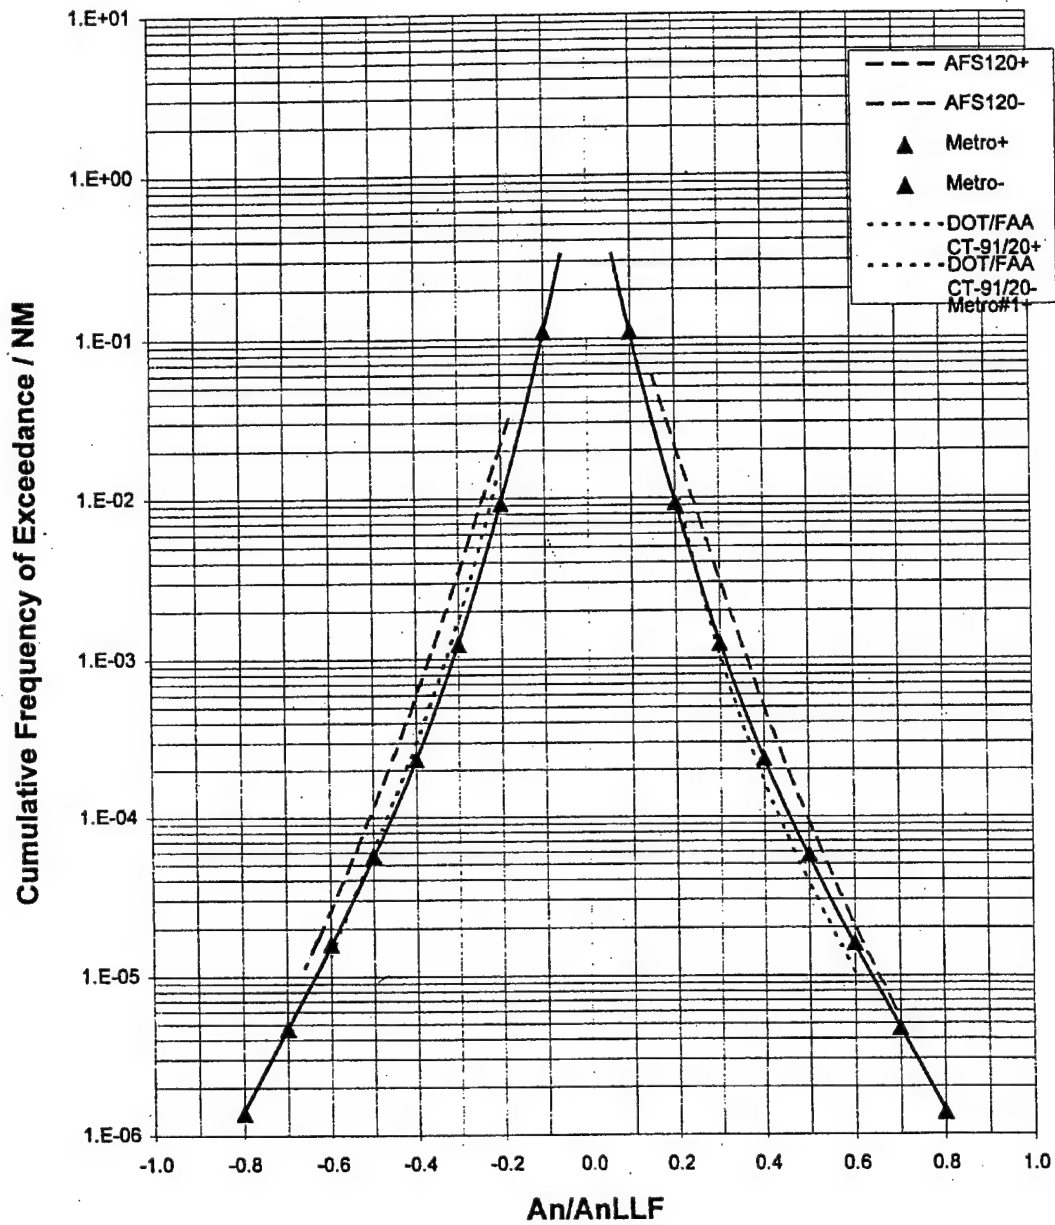
Load Spectra Comparison for Metro III
Gust, Group 2, 60 Min, 16,000 FT, 13,300 LB TO Wt.

**FIGURE 4-3 GROUP 2 FLIGHT PROFILE
 VERTICAL GUST LOADS EXCEEDANCE COMPARISON**

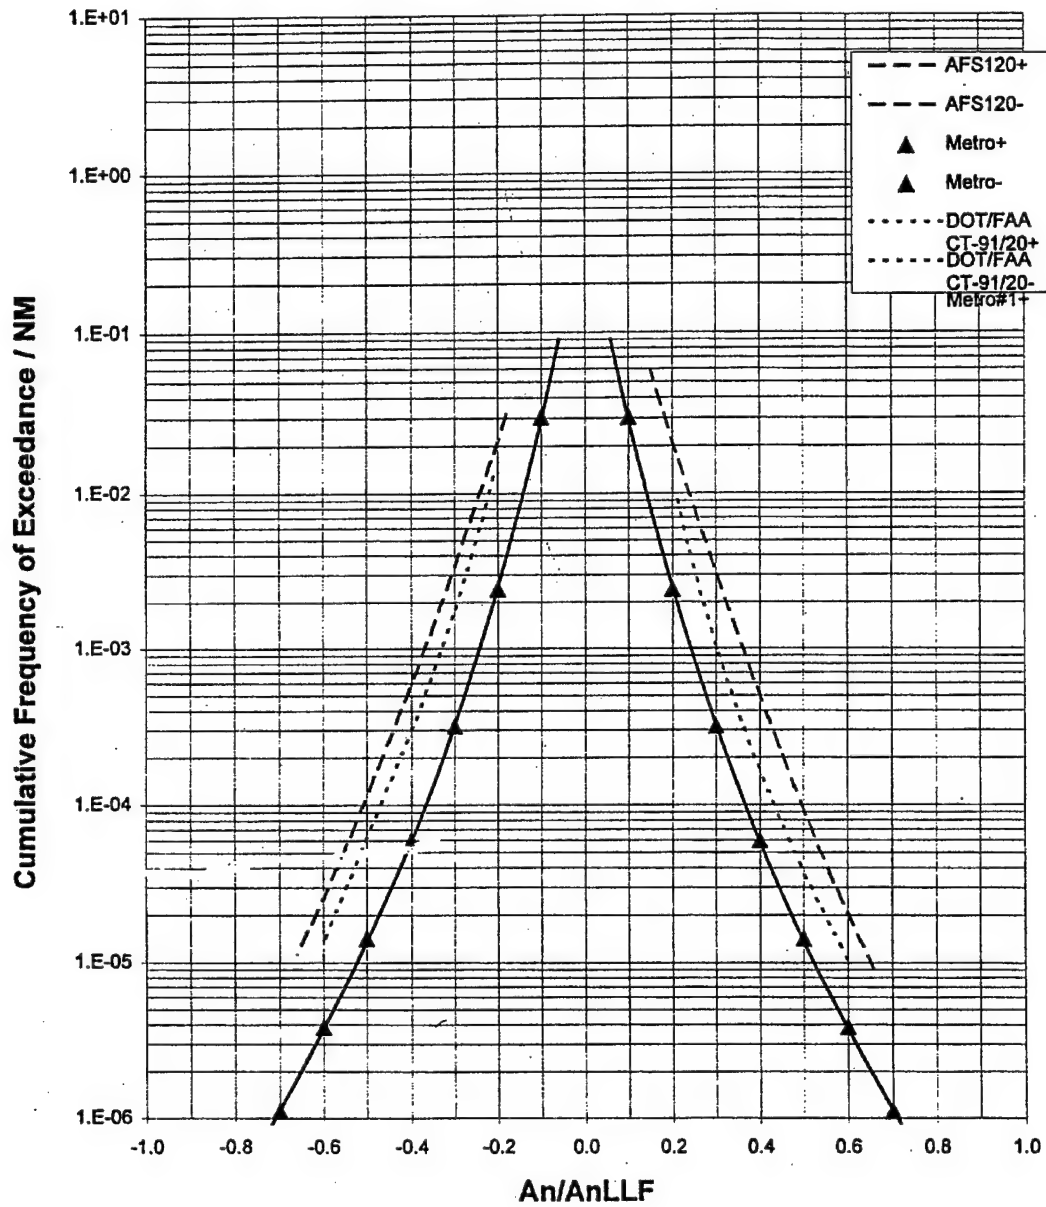
Load Spectra Comparison for Metro III
Gust, Group 3, 120 Min, 20,000 FT, 13,800 LB TO Wt.

**FIGURE 4-4 GROUP 3 FLIGHT PROFILE
 VERTICAL GUST LOADS EXCEEDANCE COMPARISON**

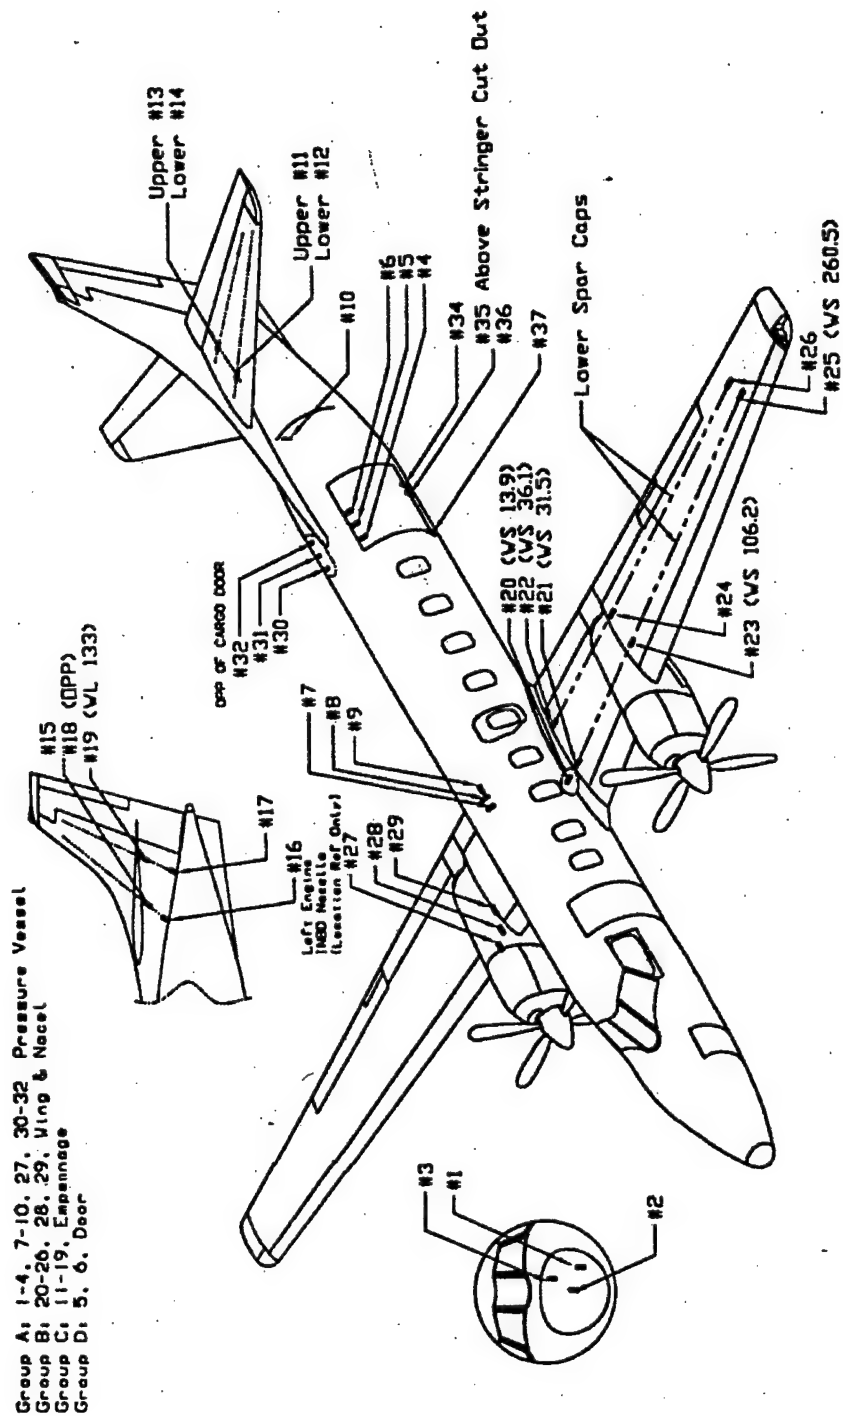
FIGURE 5-1 STRAIN GAGE LOCATIONS

A model SA227 DC aircraft serial number AC-557 was instrumented to measure strains at selected locations on the aircraft during typical flight maneuvers. A total of five flights were made to collect the data preceded by a calibration of the aircraft strain gages by the application of known loads to the aircraft. The location of the strain gages is shown on Figure 5-1.

Strain gages were located at three locations on the wing main and rear spar, on the horizontal tail main spar and rear spar near the root, and on the main and rear spar of the vertical tail. In addition strain gages were located at potentially high stress locations on the pressure vessel and nacelle. The strain gages were loaded with known loads to verify the gages were functioning properly. The data were recorded on the hard disk of a PC on the aircraft by a virtual instrument developed using LabView for Windows software. The analog to digital boards on the aircraft are capable of recording voltages equivalent to about 40-psi stress. For this reason some of the plots discussed are somewhat ragged looking when displaying very low stress levels.

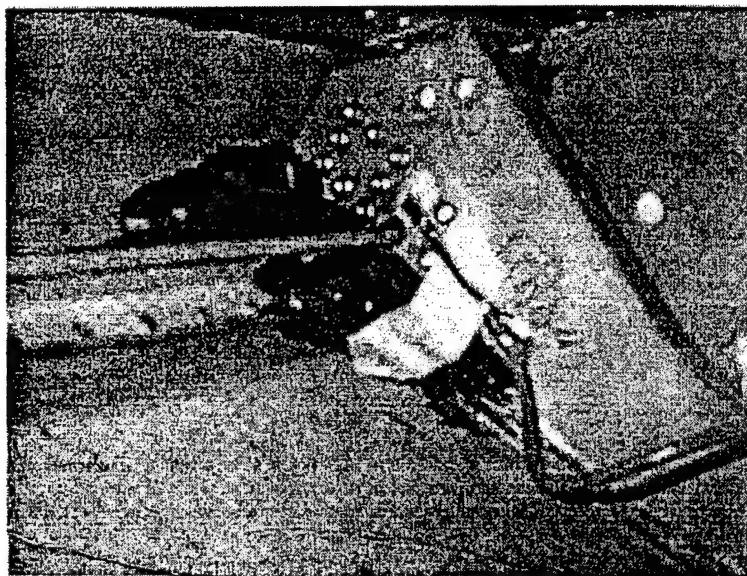
FIGURE 5-2 STRAIN GAGE 34

shown in Figure 5-2 through Figure 5-4. The stresses measured by these gages are shown in Appendix D of reference 20.

The stress measured at gage 34 was in reasonable agreement with the calculated stress. The stress at gages 35 and 36 was unexpected and did not match the stresses which caused fatigue cracks at this location during the full-scale fatigue test. After the crack was discovered during the fatigue test, the frames at this location were increased in thickness from 0.040 to 0.071 inch the local lightening holes were removed, and the tooling holes were plugged. The new configuration is the one being used in the current test. These changes are not expected to change the sign of the local stresses. The compressive stresses now measured locally may be due to variations in the local engagement of the latches that would vary from aircraft to aircraft. For this reason any analysis must assume the maximum calculated stress in these frames.

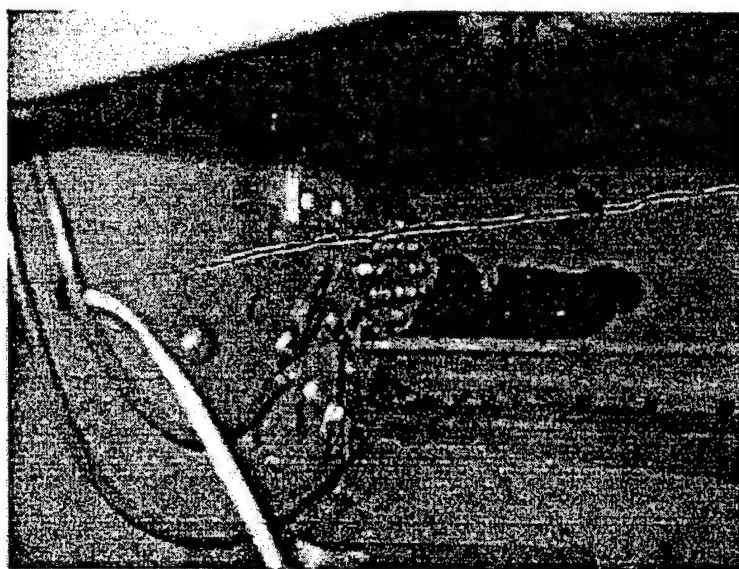
FIGURE 5-3 STRAIN GAGE 35, 36

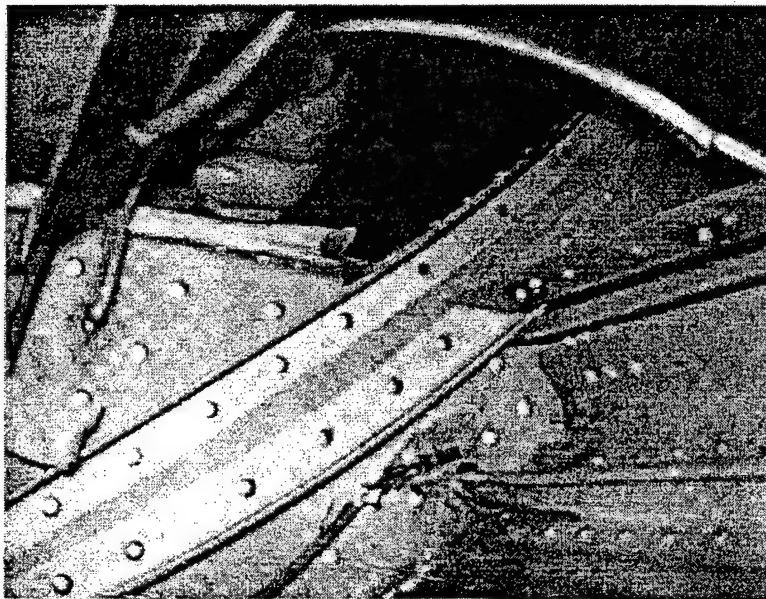
FIGURE 5-4 STRAIN GAGE 37

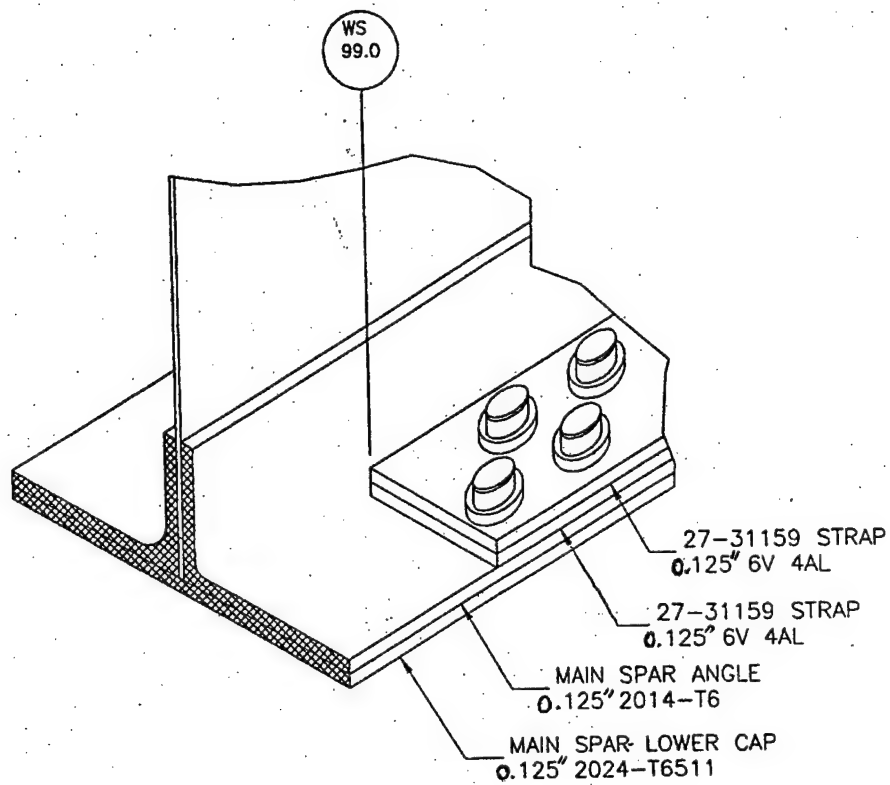
9. Inspect	Difficult to inspect. Look for crack on exposed center ridge of spar cap.	a	11
Total Score			64

**FIGURE 6-1 W1 - SA226 MAIN SPAR LOWER CAP AT WING
STATION 99.0**

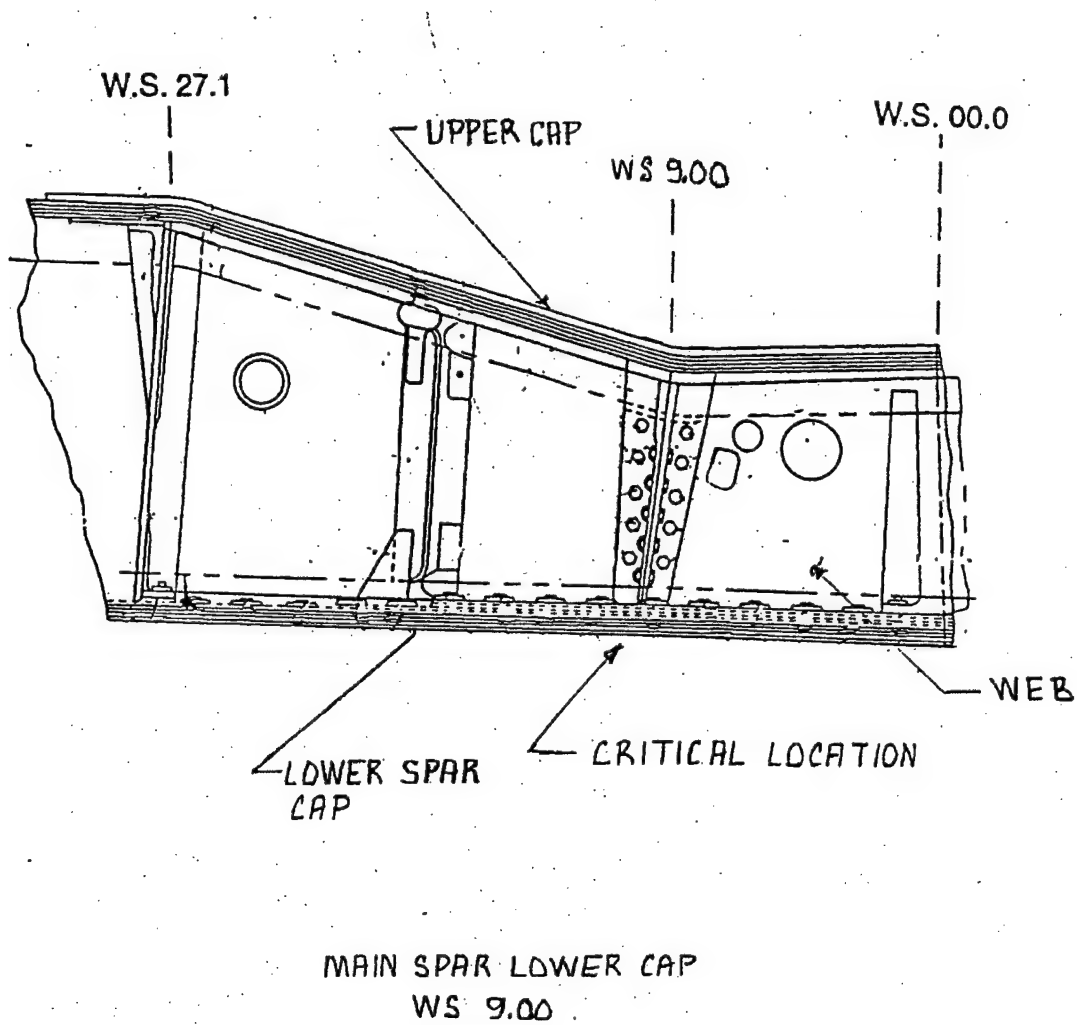
7. K _t	Minor local bending.	c	3
8. Accidental Damage	Low probability of damage. Away from propellers and baggage and service vehicles.	d	2
9. Inspect	Difficult to inspect. Look for crack on exposed center ridge of spar cap.	a	11
Total Score			58

FIGURE 6-2 W2 - SA226 MAIN SPAR LOWER CAP AT WING STATION 9.0

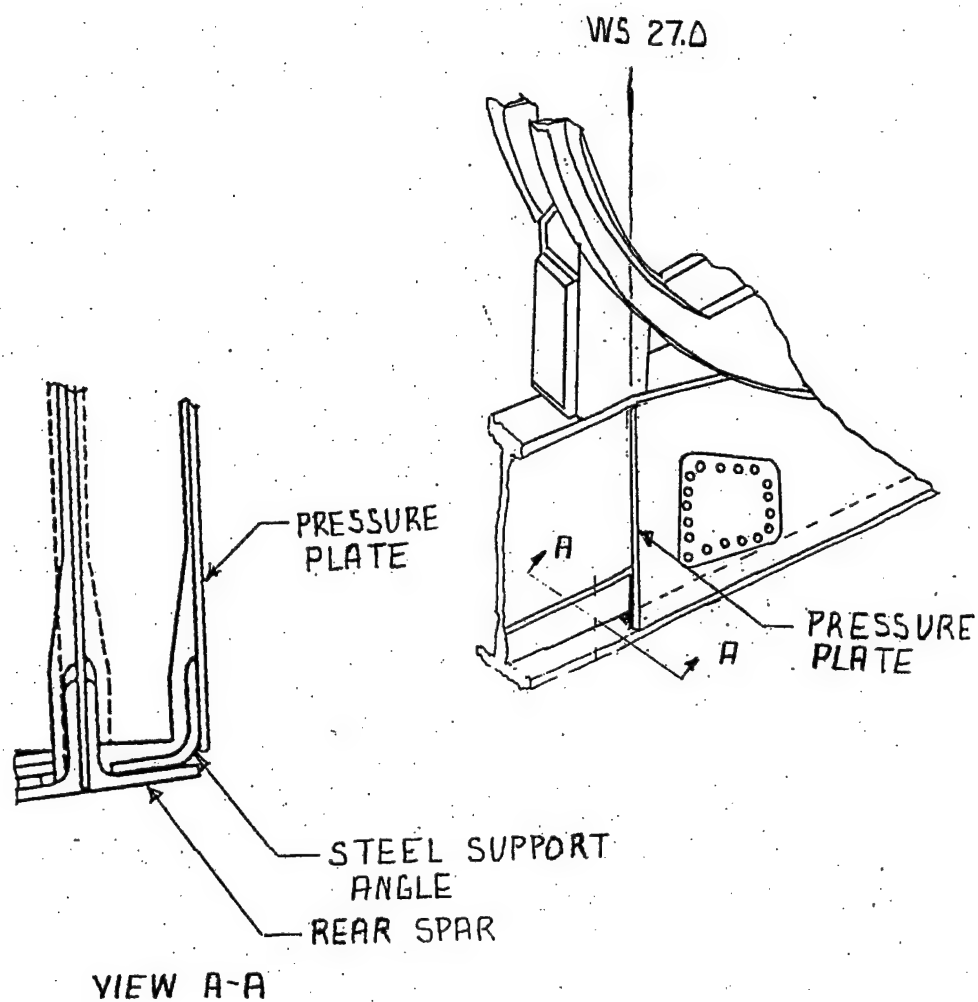
9. Inspect	Difficult to inspect. Modification may be needed.	a	12
Total Score			60

FIGURE 6-3 W3 - SA226 REAR SPAR LOWER CAP AT WING STATION 27.0

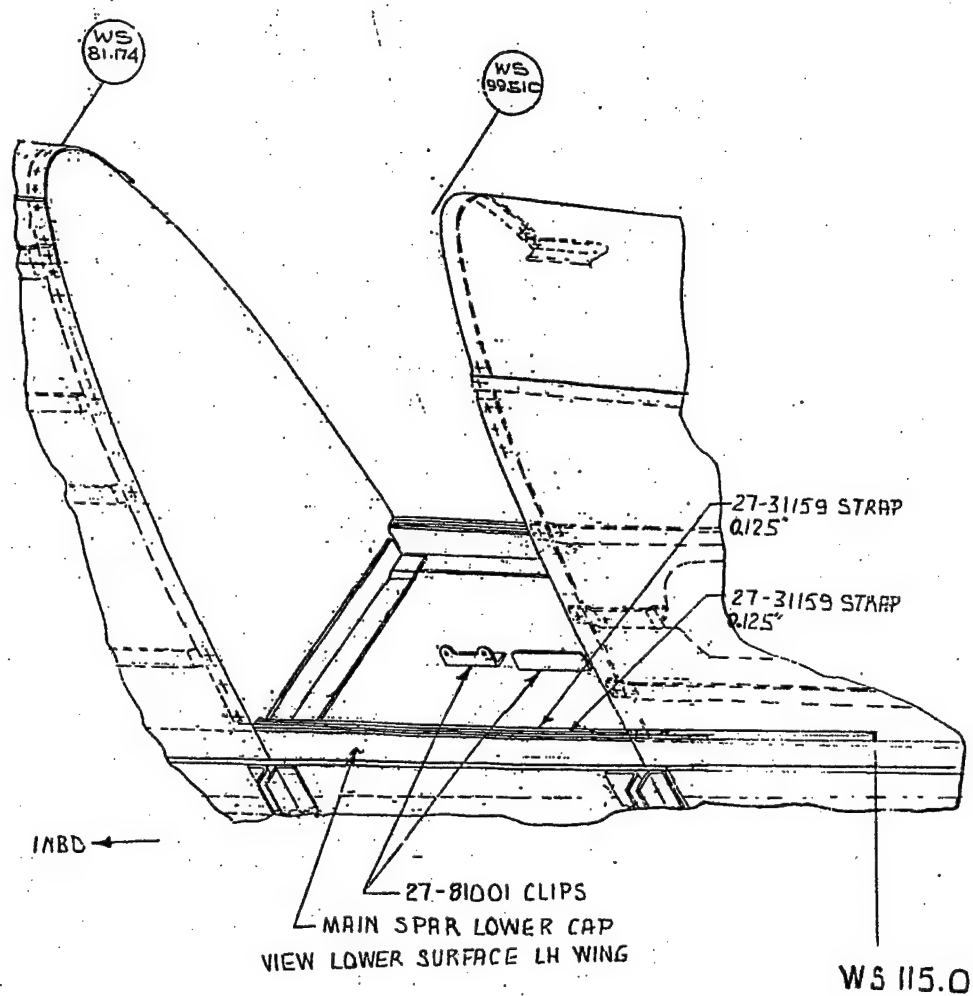
9. Inspect	Difficult to inspect.	a	12
Total Score			63

FIGURE 6-4 W4 - SA227 MAIN SPAR LOWER CAP AT WING STATION 99.0

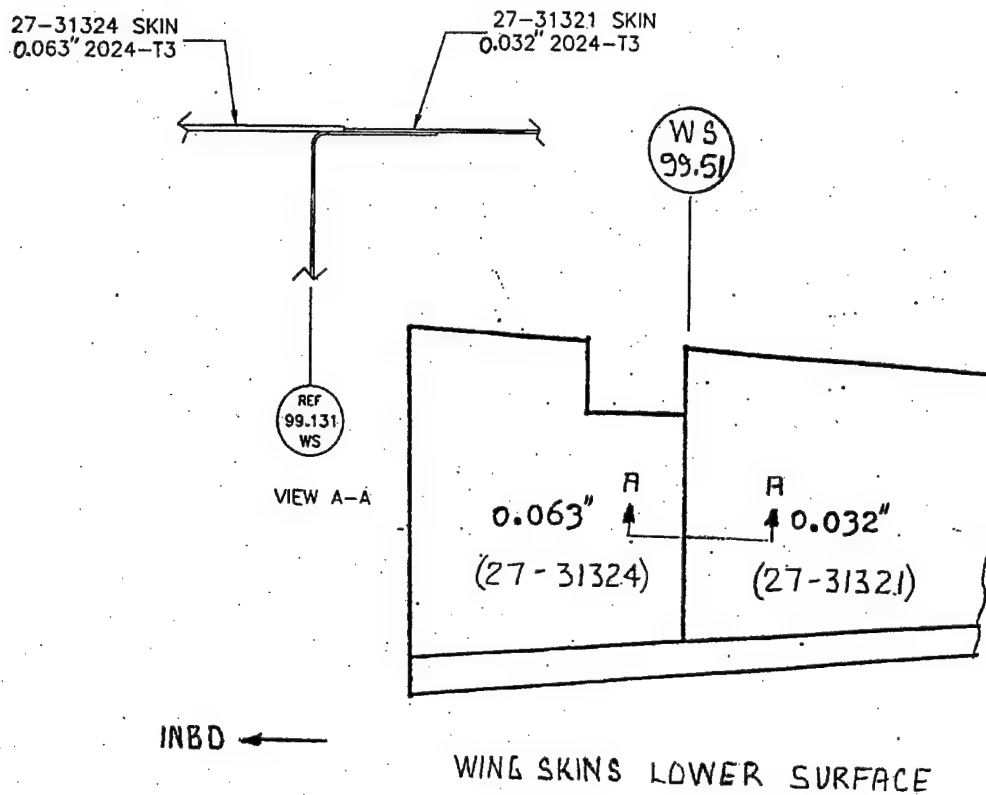
9. Inspect	Difficult to inspect directly. Look for fuel leaks.	d	4
Total Score			55

**FIGURE 6-5 W5 - SA227 SKIN SPLICE AT WING STATION
99.51 LOWER SURFACE**

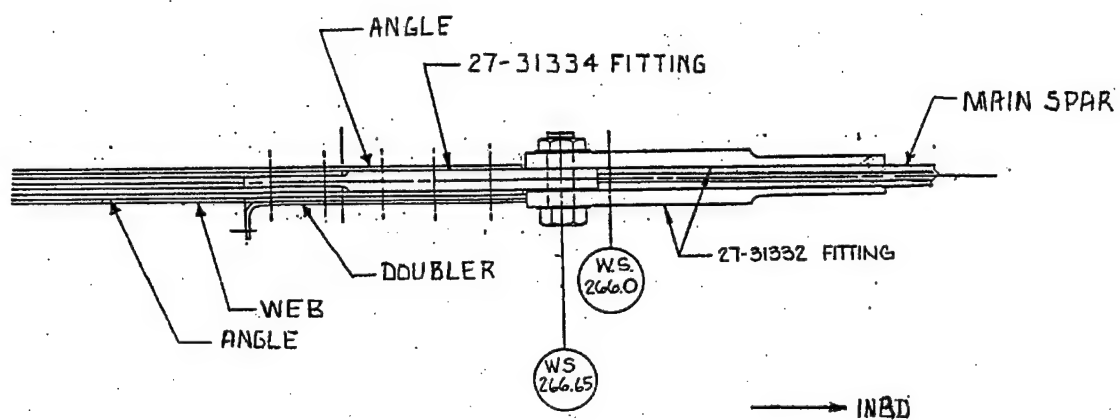
9. Inspect	Difficult to inspect directly. Remove skin panel.	c	6
Total Score			44

WING EXTENSION FITTING MAIN
SPAR LOWER SURFACE
VIEW LOOKING FWD

**FIGURE 6-6 W6 - SA227 WING EXTENSION FITTING MAIN
SPAR LOWER SURFACE**

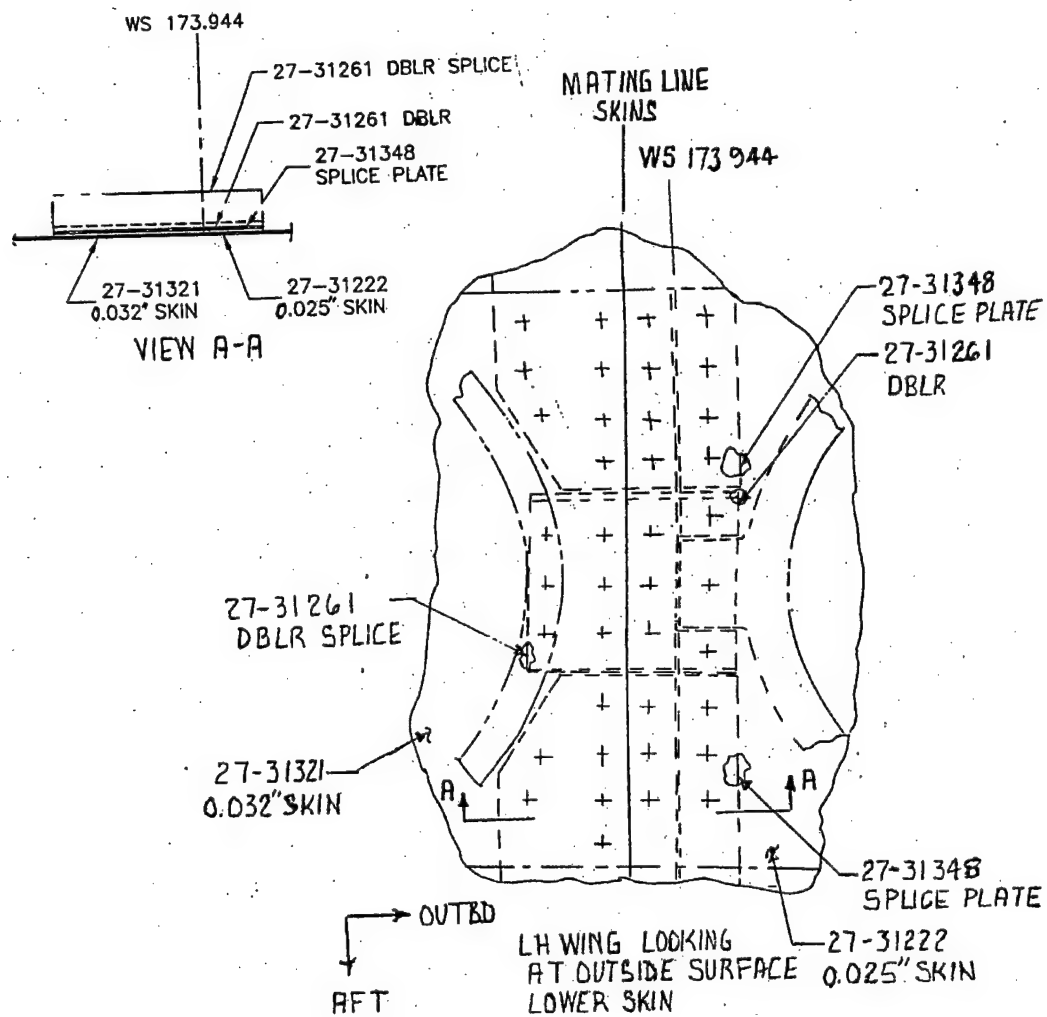
9. Inspect	Easy to inspect directly. Look for fuel leaks.	e	2
Total Score			41

**FIGURE 6-8 W8 - CHORDWISE SKIN SPLICE AT W.S. 173.944
LOWER SURFACE**

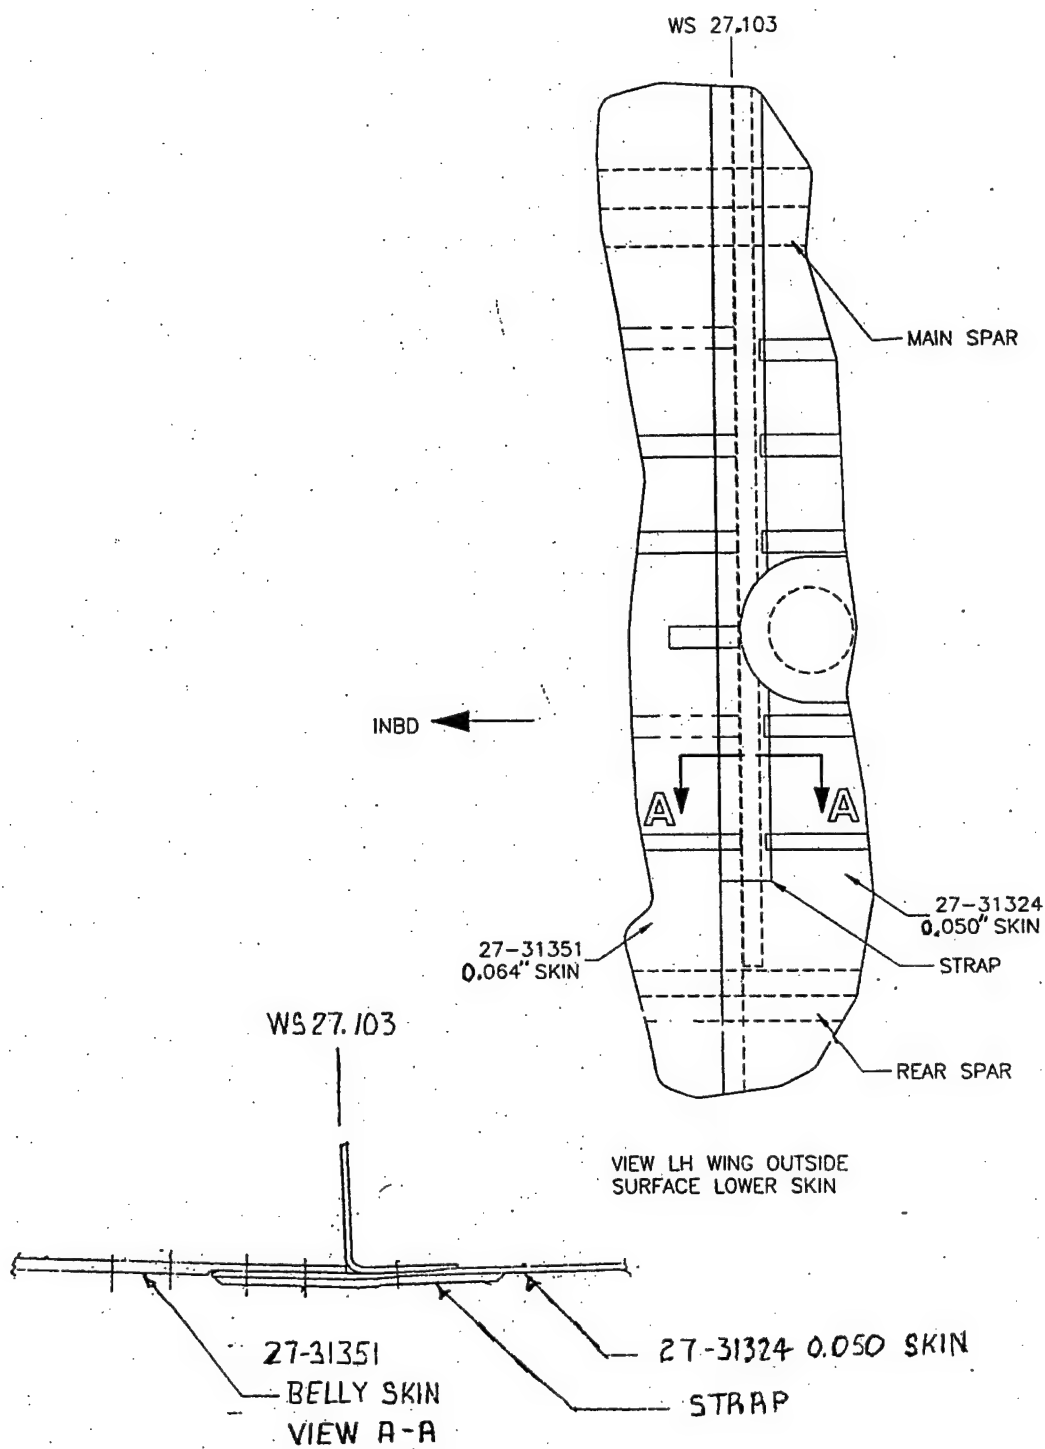
7. K _t	Double row of loaded fasteners.	b	6
8. Accidental Damage	Low probability of damage. Away from propellers and baggage and service vehicles.	d	1
9. Inspect	Difficult to inspect directly. Look for fuel leaks	a	11
Total Score			55

FIGURE 6-9 W9 - SKIN SPLICE AT W.S. 27.103 LOWER SURFACE OUTBOARD OF THE RIB

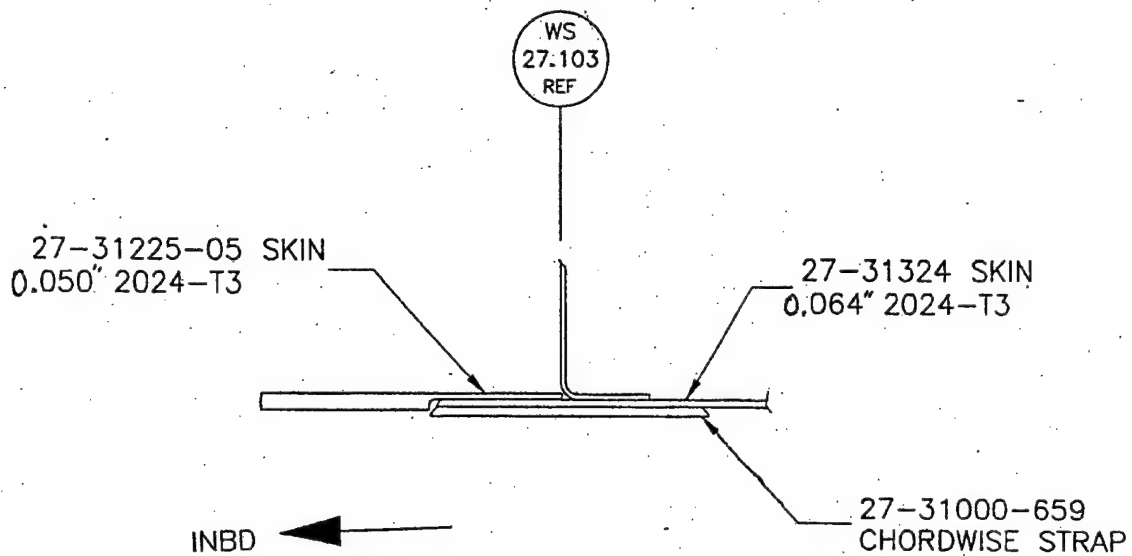
**FIGURE 6-10 W10 - SKIN SPLICE AT W.S. 27.103 LOWER
SURFACE INBOARD OF SPLICE**

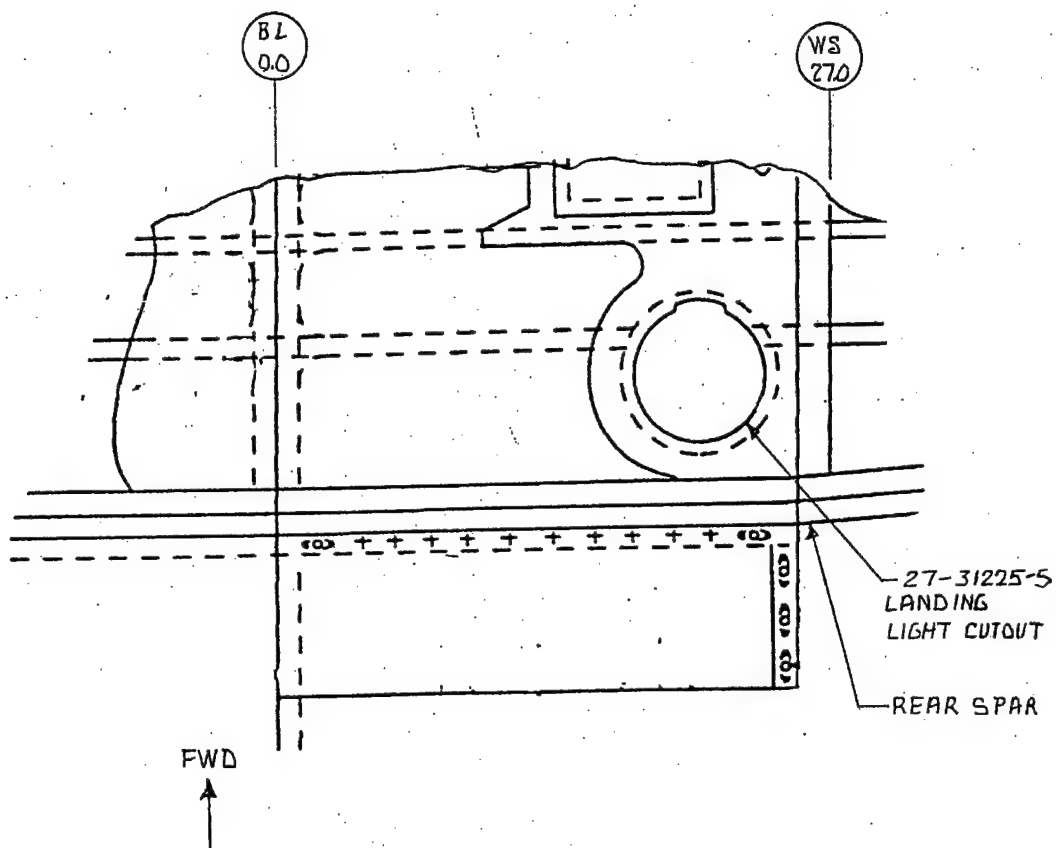
WING LOWER CENTER SECTION SKIN

FIGURE 6-11 W11 - SA226 WING LOWER CENTER SECTION SKIN AT LANDING LIGHT CUTOUT

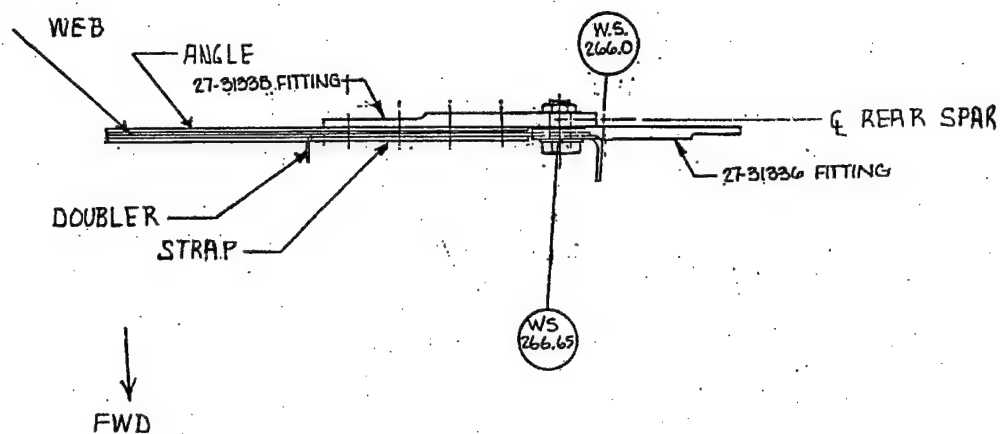
WING TIP EXTENSION FITTING
 LOWER SURFACE
 (SKIN NOT SHOWN)

**FIGURE 6-12 W12 - SA227 TIP EXTENSION FITTING REAR
 SPAR LOWER SURFACE (27-31335)**
